Contract #: 04-0120F4Cty: SF/Ala Rte: 80 PM: 13.2/13.9File #: 69.28**WELDING INSPECTION REPORT****Resident Engineer:**Siegenthaler, Peter**Address:** 333 Burma Road**City:** Oakland, CA 94607**Report No:** WIR-023899**Date Inspected:** 14-May-2011**Project Name:** SAS Superstructure**OSM Arrival Time:** 1900**Prime Contractor:** American Bridge/Fluor Enterprises, a JV**OSM Departure Time:** 700**Contractor:** Zhenhua Port Machinery Company, Ltd (ZPMC), Changxing Island **Location:** Shanghai, China**CWI Name:** See below**CWI Present:** Yes No**Inspected CWI report:** Yes No N/A**Rod Oven in Use:** Yes No N/A**Electrode to specification:** Yes No N/A**Weld Procedures Followed:** Yes No N/A**Qualified Welders:** Yes No N/A**Verified Joint Fit-up:** Yes No N/A**Approved Drawings:** Yes No N/A**Approved WPS:** Yes No N/A**Delayed / Cancelled:** Yes No N/A**Bridge No:** 34-0006**Component:** OBG Components**Summary of Items Observed:**

WELDING INSPECTION REPORT

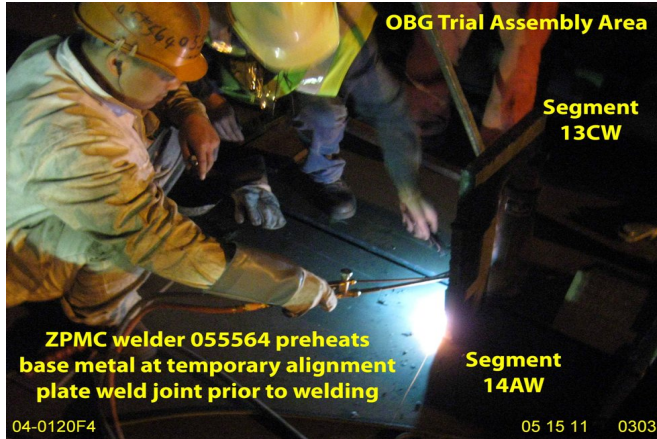
SMAW welding of temporary alignment plates located across the PCMK OBG 13CW/14W transverse joint, deck plates. Welder was identified as 055564. QC was identified as QC1. Assisting QC1 at this location and appearing to be monitoring the welding operation and recording data was QCA1, who was not a CWI. Weld variables recorded by QCA1 appeared to comply with WPS-B-T-2134-ESAB as verbally identified by QCA1. See photo below of welding operation in progress.
